State of Utah

Division of  
Oil, Gas & Mining

SUBJECT: Site Inspection, State Stone, Unpermitted Sites, M/055/021, Wayne County, Utah

**M/055/021, Unpermitted Quarries, State Stone**

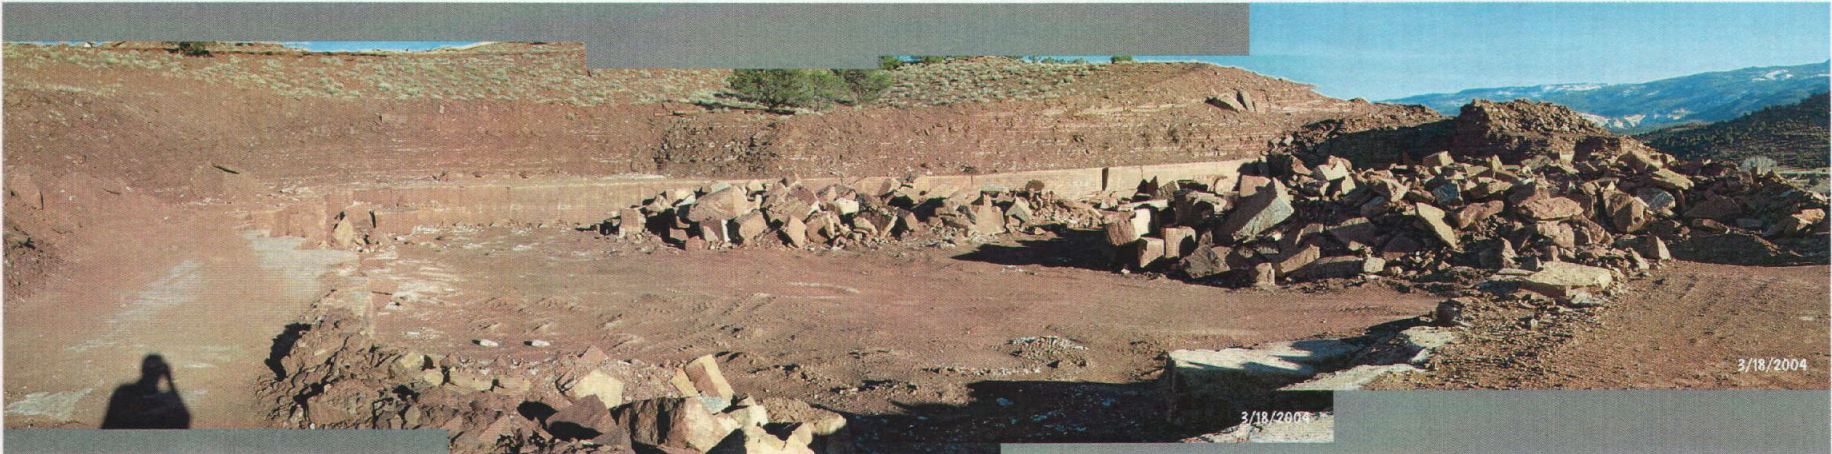
**Photo 1. Panorama of the west quarry.**

I used the GPS to take readings at the west site on March 18, 2004. This site consists of two distinct but adjoining areas, the quarry and the loading area. Photo 1 is a panorama constructed from four photos of the quarry. On the west, the quarry extends to the top of a cliff or very steep dropoff that leads to the Fremont River, but little or no material has gone over the edge. As can be seen in Photo 1, the operator has been quarrying sandstone under overburden that varies in depth from several feet on the east to almost nothing on the west.

On March 4, 2004, the Division issued a notice of noncompliance to State Stone for operating the east quarry site without first filing a Notice of Intention to Commence Large Mining Operations, the permit fee, and a reclamation bond. Based on the current inspection, the west quarry needs to be included as part of the operation, but the operator should be given the opportunity to reclaim a portion of the east quarry. The amount of bond to be submitted can be adjusted taking into consideration how much area remains disturbed.

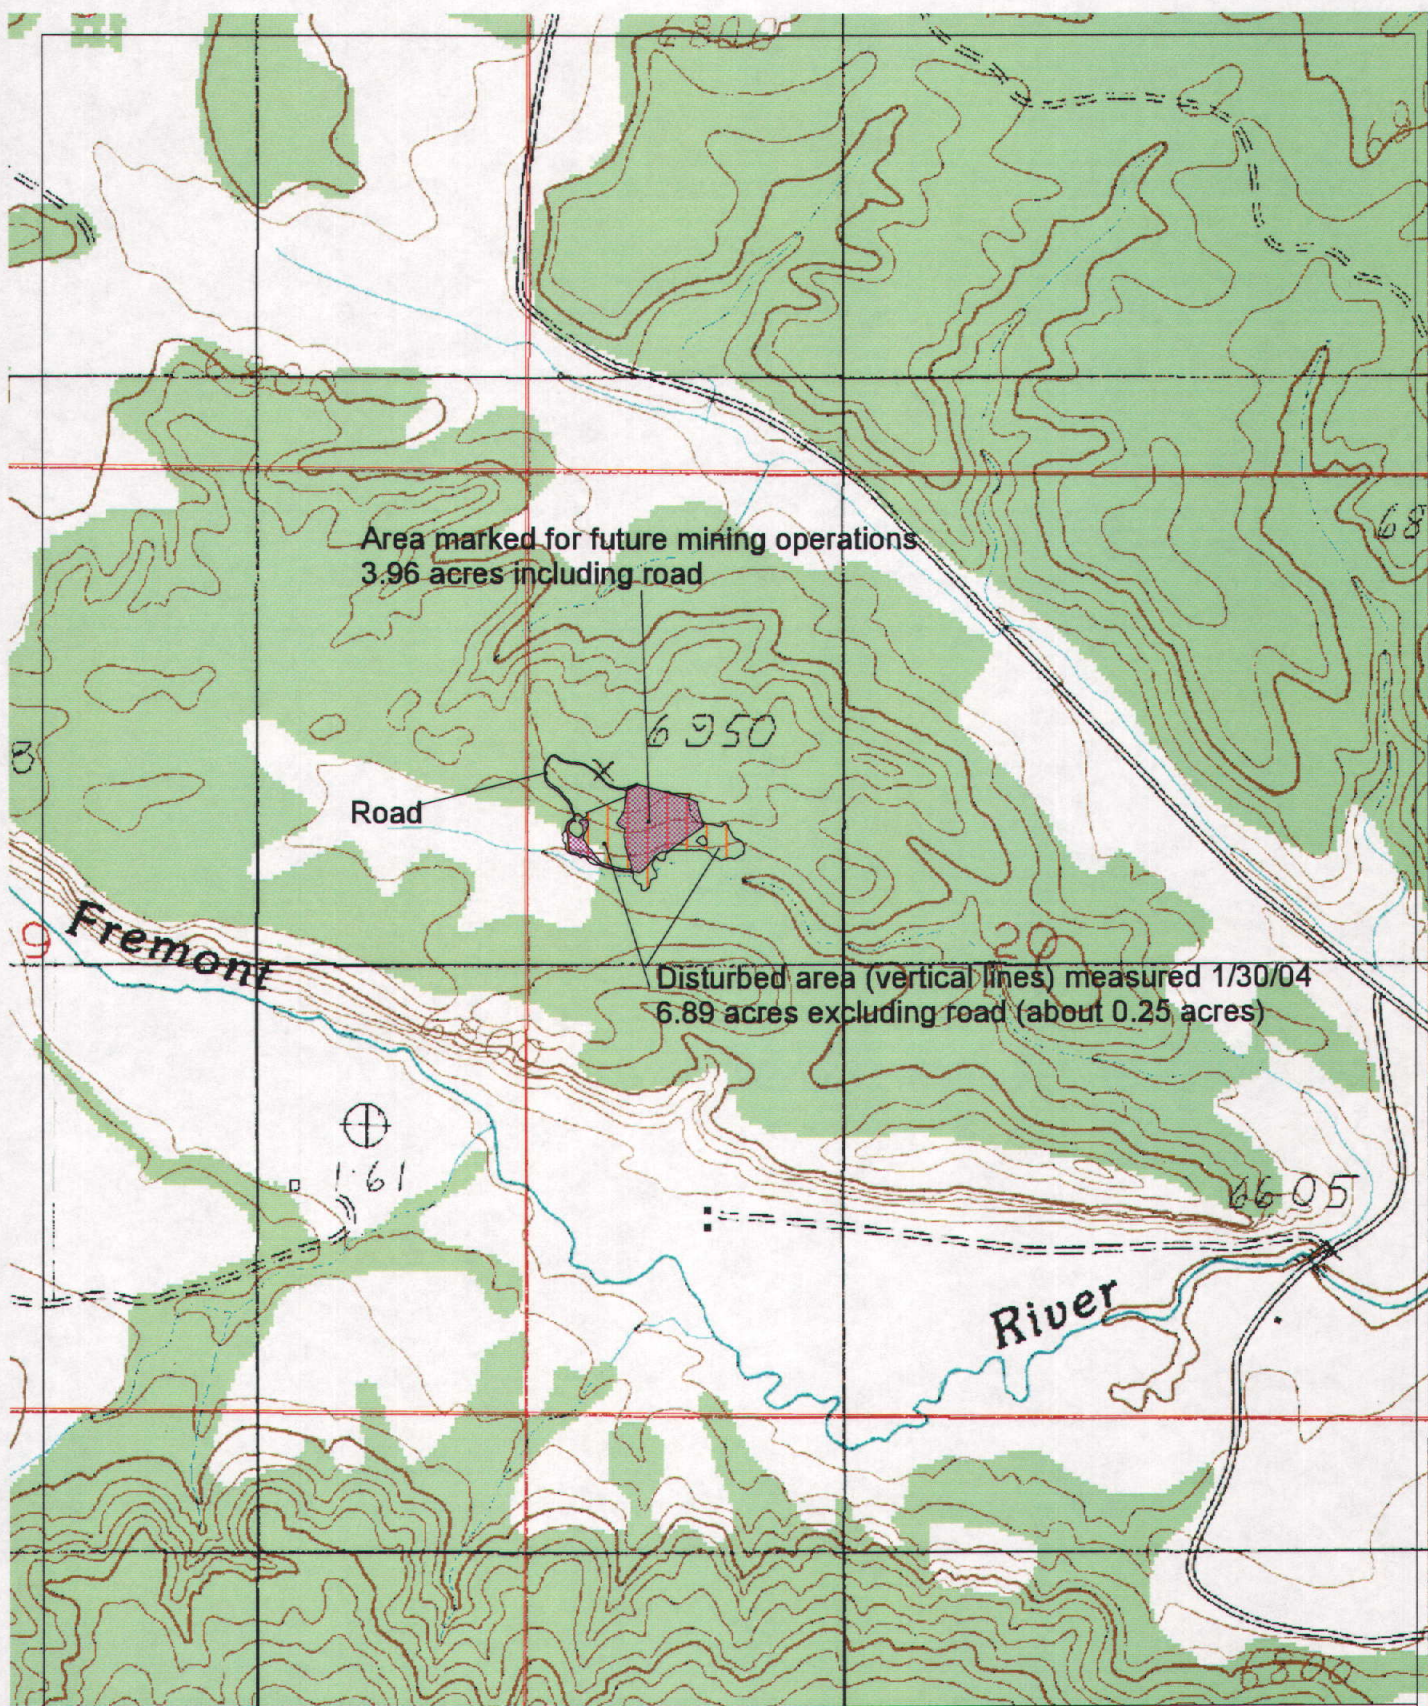
Mine Number: M/055/021 (East Site)  
Mine Name: State Stone  
Township 29 S Range 5 E Section 20 SLBM  
Torrey Quad

There have been no changes in site conditions at the east site. During the inspection, I had Mr. MacKay and Mr. Oyler direct me to what they would consider the boundaries of the area they will need for future mining, and I used a GPS unit to create a map of this area. The map is attached to this report. The map is labeled "Mine Number: M/055/021 (East Site)." On this map, the larger purple stippled area is the mining area, and there is a smaller area on the west that includes the powder magazine, a turn around area, and a road leading from the base to the top of the mine site. The mining area was measured as being 3.31 acres, and the other features were 0.65 acres for a total of 3.96 acres.

We placed rock piles at corners of the area that will be needed for future mining, and I asked Mr. Oyler and Mr. MacKay to replace these piles with more permanent markers, such as t-posts.
